CONNECTICUT RIVER BASIN LYNDON, VT

INSTITUTE POND DAM VT 00216

PHASE I INSPECTION REPORT NATIONAL DAM INSPECTION PROGRAM

DECEMBER 1980

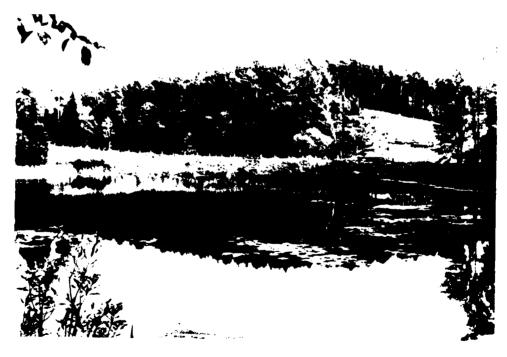
#1 - Crest of Dam, from State Aid Highway #9(notice 48 inch culvert, discharge end, lower left corner) (photo location on Possible Flood Damage Area Map-Appendix D)
